ROCKFALL HAZARD STUDY

NORTH MAIN APARTMENT PROJECT

DURANGO, COLORADO

PROJECT NUMBER: 55089GE

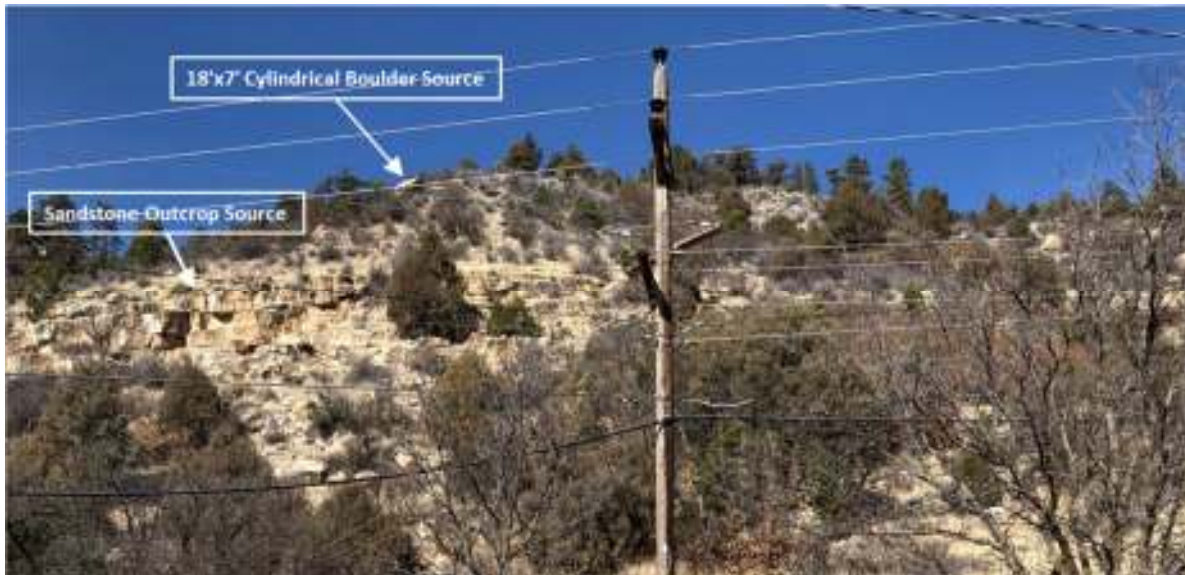
Figure 3: Photograph taken from the project site looking up the slope along the south path.

Rockfall hazards influence the subject property. The primary source(s) of rockfall are from the Dakota Sandstone (Kd*) and sandstone beds within the Morrison Formation (Jm*). These sources exist as outcrop and in the form of loose boulders lying precariously on the slope above the lot. The source rock yields very large fragments – some over 18 feet in length – due to jointing patterns and slight metamorphism. Much of the loose boulder source rock is resting in a place to which it fell (i.e. prior rockfall events existing as potential subsequent event source). There are numerous sources of rockfall originating from the top of the slope to approximately 100 feet above the site.

Recent rockfall is evidenced on the slope above the site, however due to prior grading and development all evidence of rockfall within the project site has been removed. Without this evidence, the historical record and adjacent areas are our best indicators of rockfall. The Merced de las Animas residential property - neighboring to the south - has experienced destructive rockfall, subsequently imposed mitigation, and has since experienced rockfall events that have been successfully mitigated.

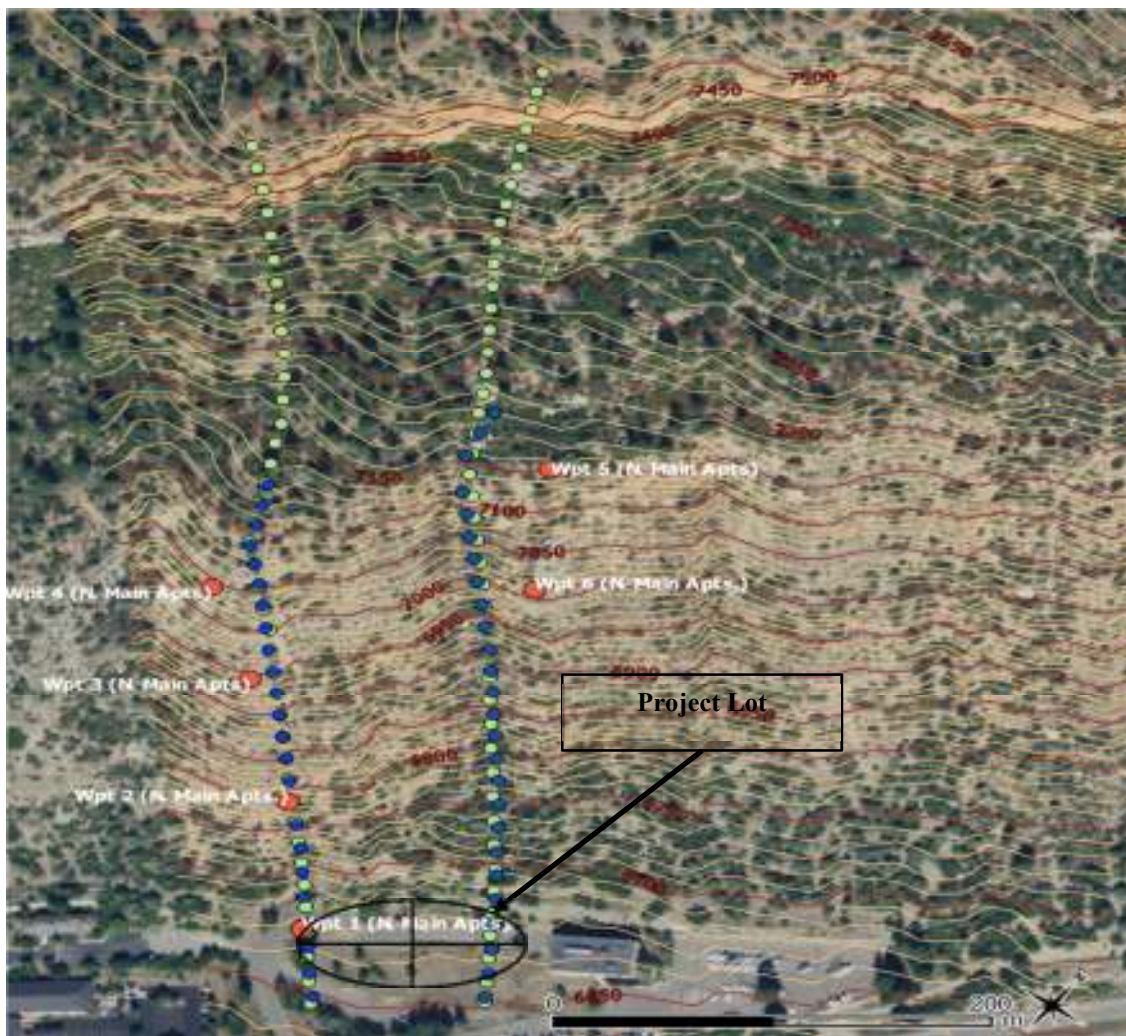
Figure 4: Vicinity Map and Aerial Photo showing topography (10 foot contour interval), lot location, rockfall paths analyzed in CRSP (blue dots show below upper bench path, green dots show full path), and handheld GPS waypoints (orange dots) from field reconnaissance

We evaluated the rockfall behavior at the subject property using CRSP Version 4.0. CRSP is a computer modeling tool to aid in the evaluation of rockfall behavior and provides estimated impact energies and bounce heights of rockfall events. This information may be utilized in the design of rockfall protection measures. We created an approximate topographic cross section using a tape measure, Brunton compass, and a hand held GPS unit. We created two additional cross sections using a geographical information system (GIS) software and a one meter resolution digital elevation model (DEM) provided by the United States Geological Survey (USGS). The hand measured alignment coincides with one of these GIS derived alignments in order to corroborate results. Therefore we analyzed two different rockfall paths, referred to as the north path and south path. The north path cross section was made from the DEM in the GIS program and models were run with and without the upper bench and above. The south path cross sections were made from the DEM and from field measurements. The field measured south path did not model the upper bench and above, however the DEM derived model was run with and without the upper bench and above. The alignment of these cross sections are shown in Figure 4.

We utilized CRSP to simulate the existing conditions at the subject property. We manipulated the model's input parameters such as surface roughness, tangential, and normal coefficients to approximate the existing conditions. Once we were satisfied that we had simulated the existing conditions, we performed numerous iterations of rockfall with the program while varying sizes and shapes of rocks to model the rockfall behavior at the proposed development. In all of the models, analysis point 1 represents the downhill edge of the bench/trail along the northwest edge of the property boundary (similar to the location of the neighboring rockfall fence). Analysis Point 2 represents the proposed structure.
